## **Inspector's Daily Report**

| IDR Sheet | 1 | of | 1 | Sheets | Final Record Book | Page |
|---|---|---|---|---|---|---|
| C-7852 | | | | Wednesday | | October 20, 2010 |

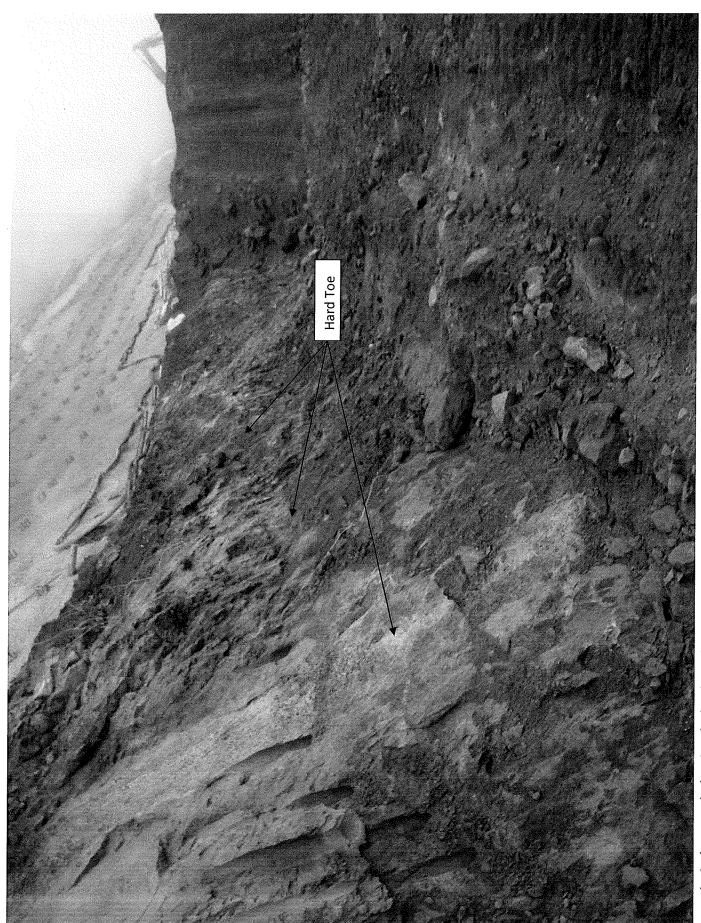
I met Brad Schut (WSDOT Inspector) on the east end of the project to visually inspect the excavation of blast SN6. The contractor had only excavated the upper 8 to 10 feet and numerous hard toes were observed throughout the excavated limits that began towards the upper portion of the lift (Figure 1). Brad and I also noticed many of the pre-split holes (half casts) were not on one-foot centers (Figure 2).

Figure 1. A photograph showing the hard toes located within the excavated limits of blast SN6. Note how close the hard toes are to the top of the lift.

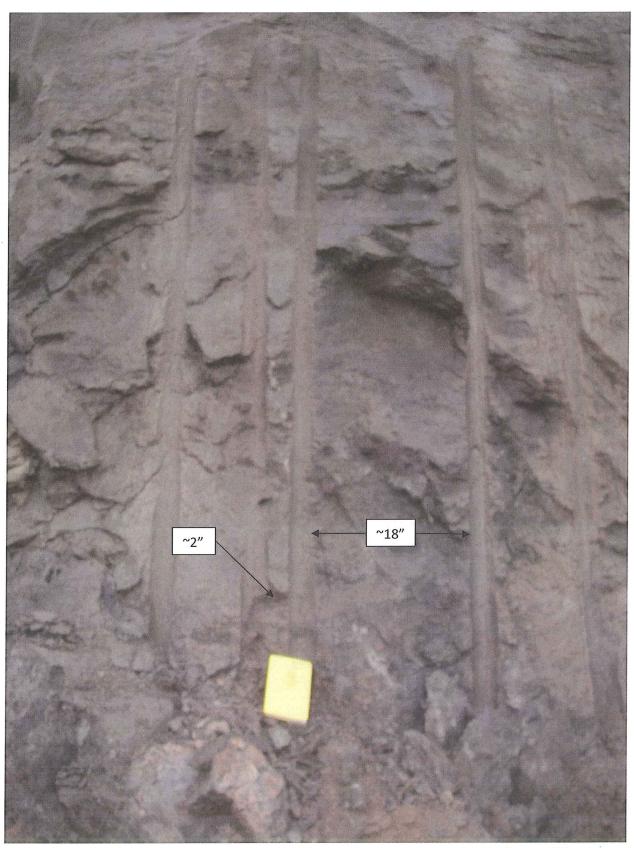
Figure 2. A photograph showing the uneven spacing of the pre-split holes within the limits of blast SN6.
